**Marine Biological Survey
Pinellas County Shore Protection Project
Comprehensive Borrow Area Study**

February 2002

**Prepared for:
Jacksonville District
U.S. Army Corps of Engineers
400 West Bay Street
Jacksonville, FL 32202**

**Prepared by:
Dial Cordy and Associates Inc.
490 Osceola Avenue
Jacksonville Beach, FL 32250**

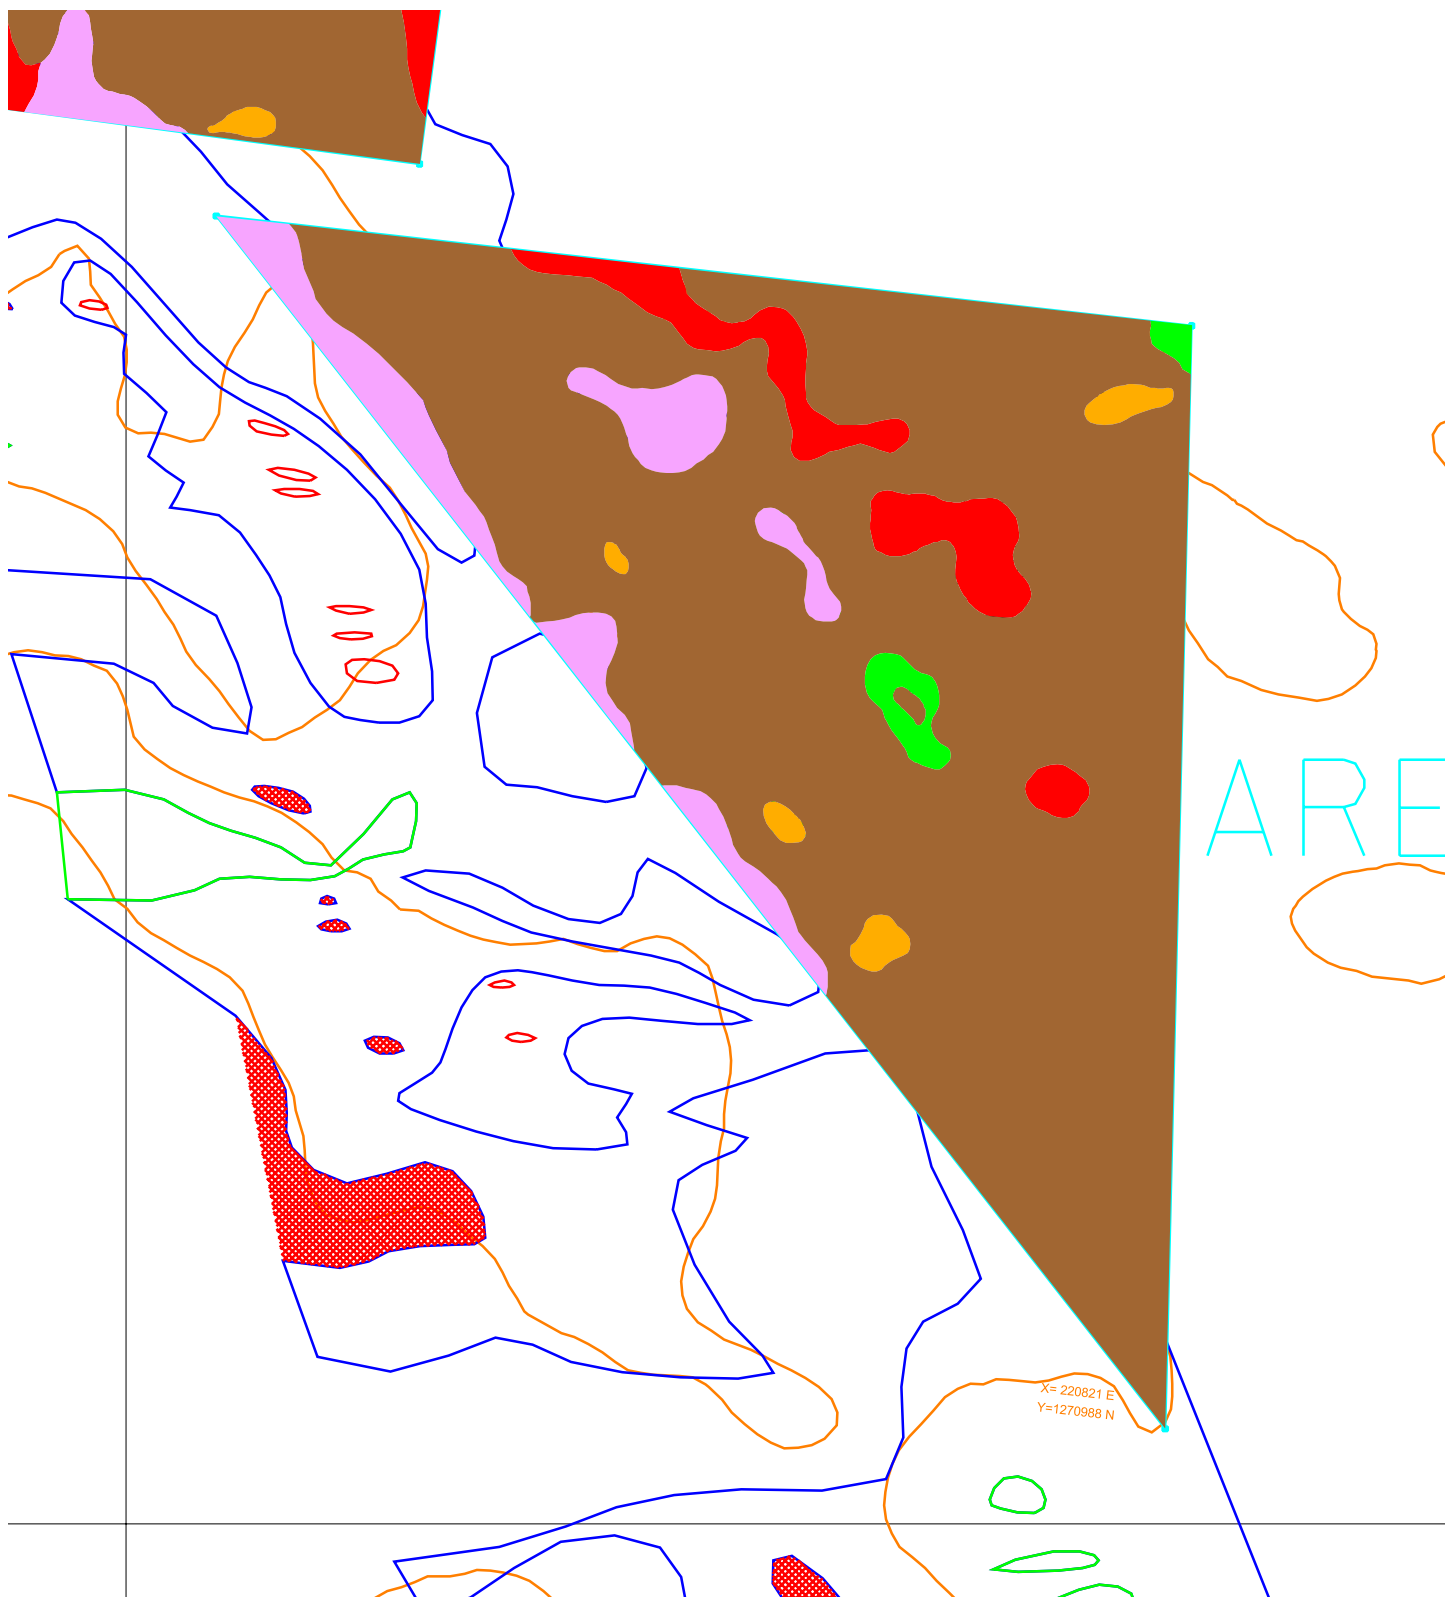
DIAL CORDY AND ASSOCIATES INC. Environmental Consultants	J01-493
	Figure 19

Pinellas Borrow Area Bottom Classification Map

- Dense Hardbottom (>75% Cover), High Relief (>100 cm)
- Dense Hardbottom (>75% Cover), Medium Relief (30cm-100cm)
- Scattered Hardbottom (20% - 75% Cover), Medium Relief (30cm-100cm)
- Scattered Hardbottom (20% - 75%, Cover), Low Relief (<30cm)
- Patchy Hardbottom (<20% Cover), Low Relief (<30cm)
- Sand

The largest borrow area surveyed was Area H (Figure 19). In total, Area H encircles 3,202.1 acres of seafloor, 2.8 miles offshore of Sand Key. Within this area there was a total of 2533.8 acres of open sand habitat, the largest of all areas surveyed. This represents 80 percent of the total acreage within Area H. Hardbottom habitats within this potential borrow area covered 668.3 acres.

Habitat distributions varied across Area H. In the western half of the borrow area, randomly distributed patches of scattered medium relief hardbottom were typical (Figure 19). These areas vary in size from small areas (< 1.0 acre) to large tracts of hardbottom (70 acres). In the eastern half of Area H, the northeast section is composed of a large area of open sand habitat. This area encompasses over 2,500 acres of area. Vertical relief of resources within Area H averaged just over 30 cm (Photograph 12). Marine resources here were similar to those found in other areas, with large sponges and gorgonians being the dominant species. Numerous sea robins were also seen on the sand areas interspersed between hardbottom areas.

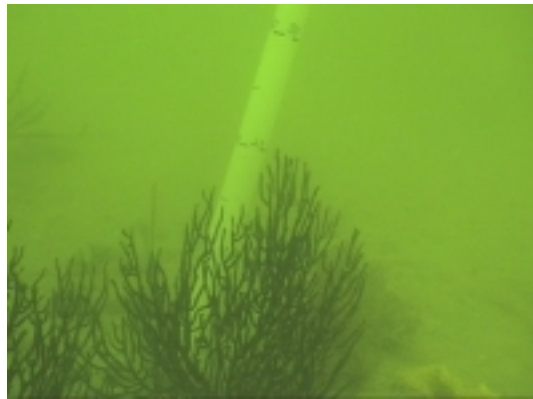
Photograph 12. Typical relief of hardbottom in Area H.

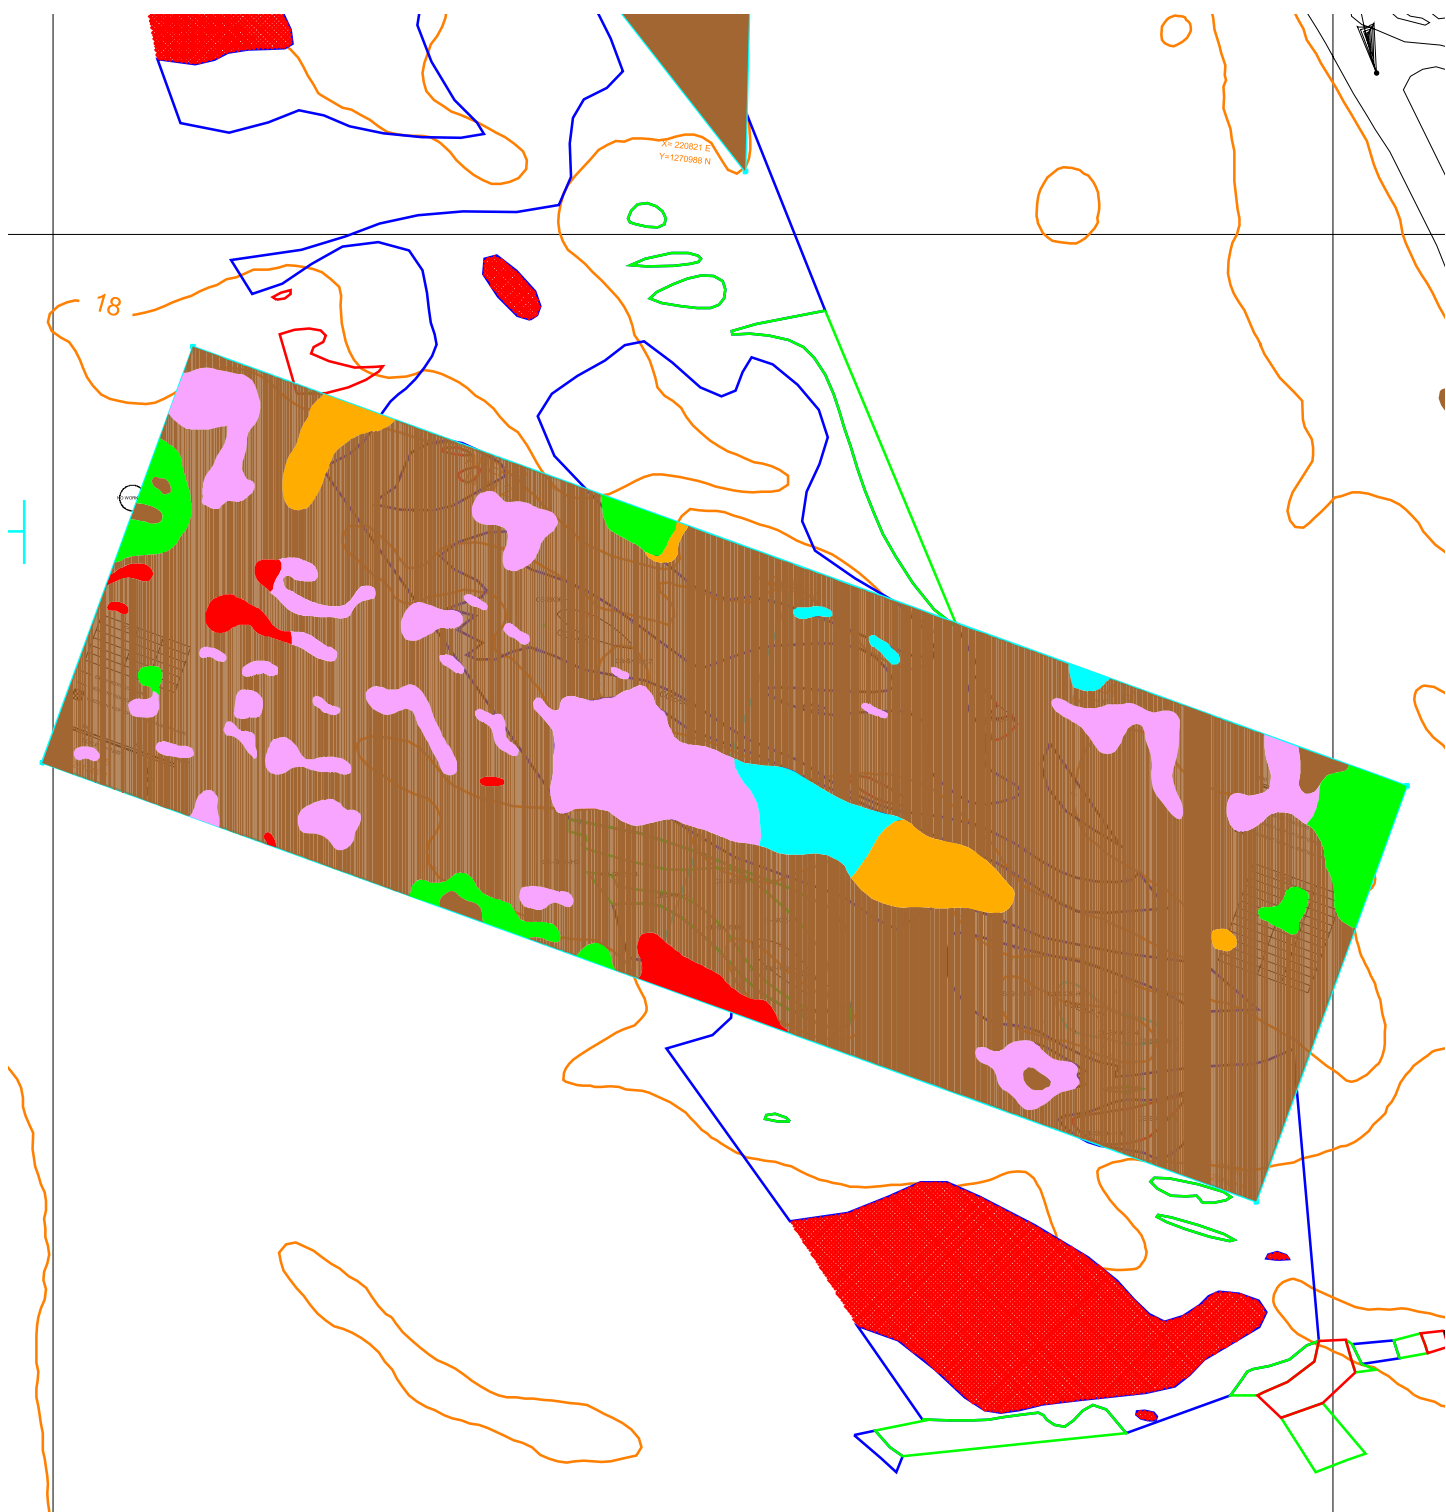
Pinellas Borrow Area Bottom Classification Map

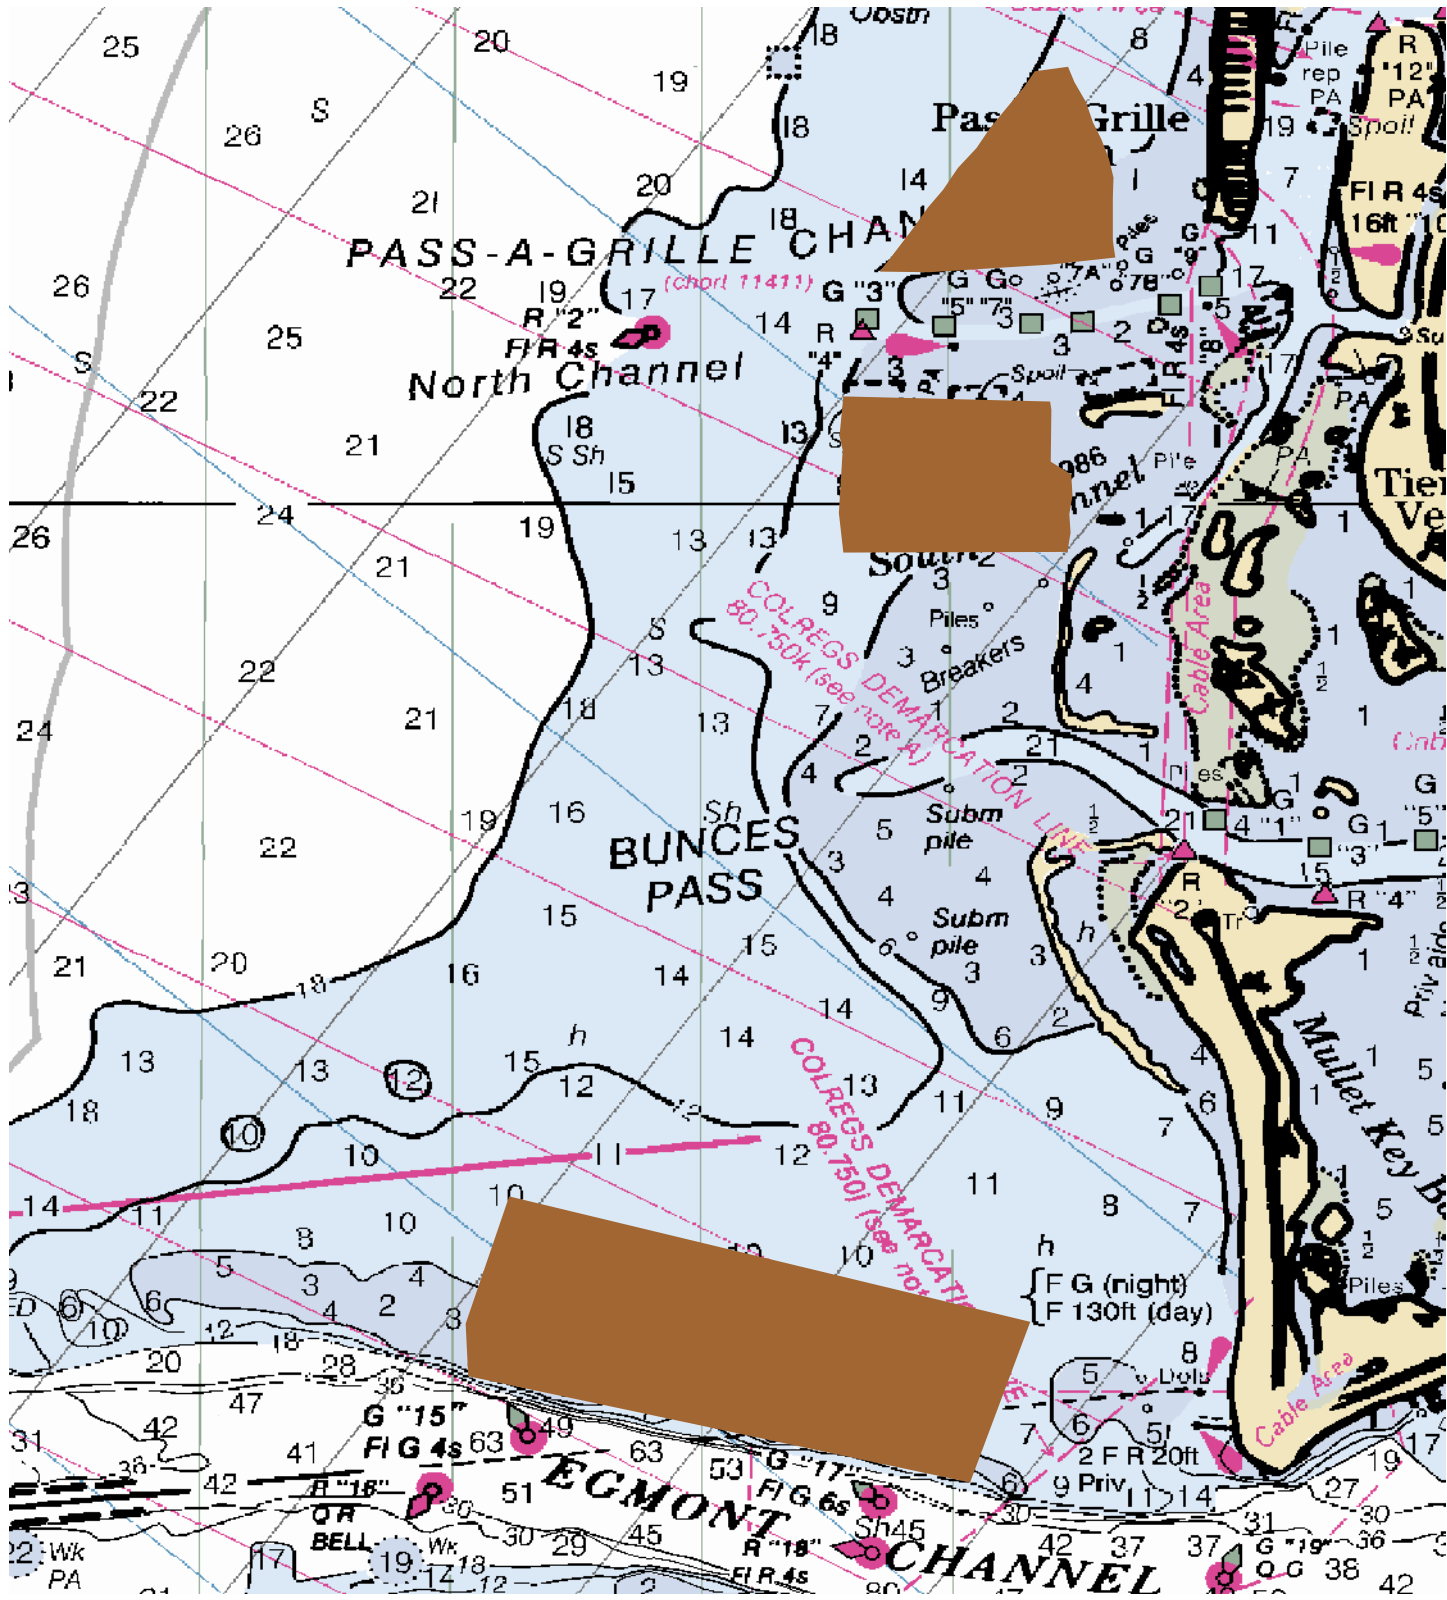
Figure 22

Ebb Tidal Shoals Bottom Classification Map

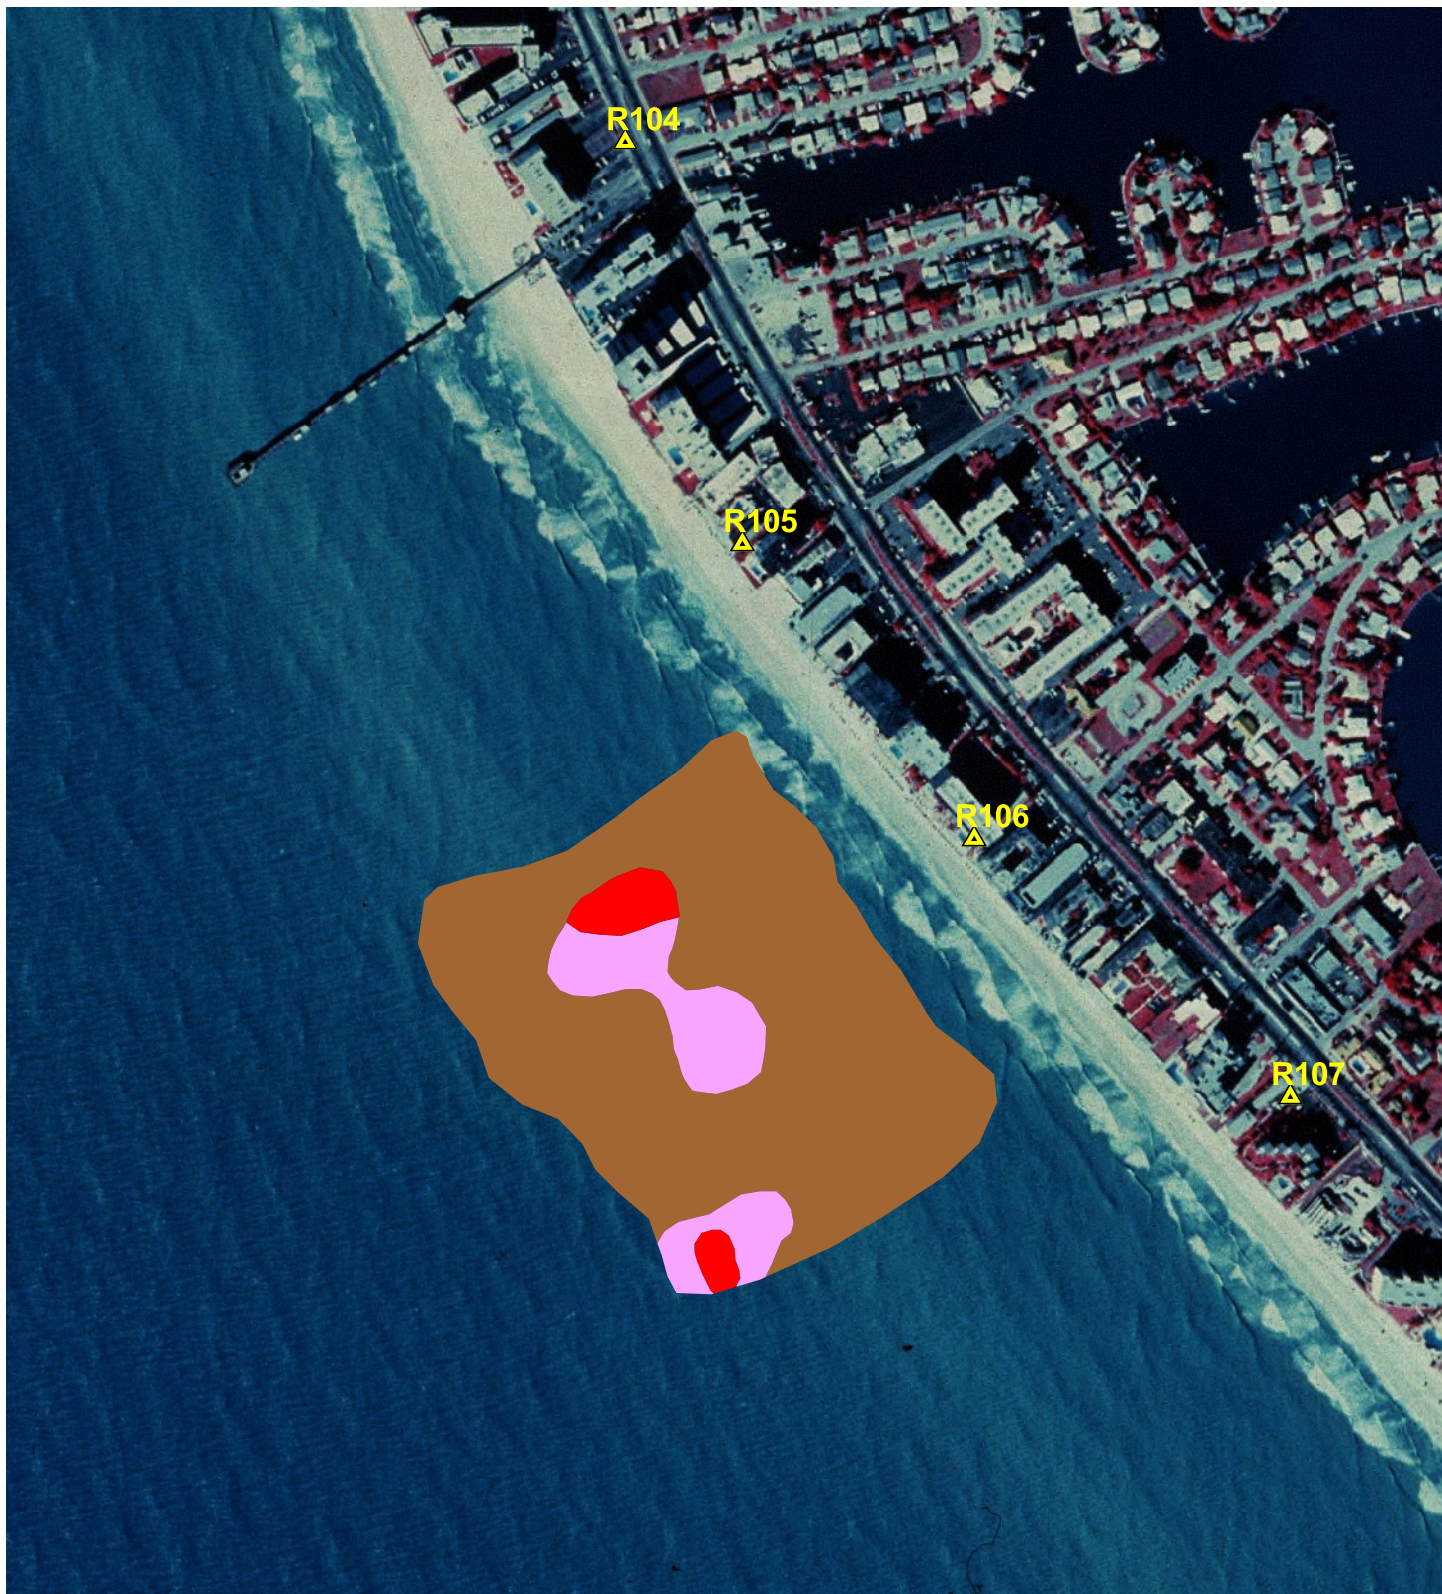
Figure 23

- ▲ FDNR Range Monument
Pinellas Nearshore Bottom Classification Map
 ■ Dense Hardbottom (>75% Cover), High Relief (>100cm)
 ■ Scattered Hardbottom (20-75% Cover), Medium Relief (30-100cm)
 ■ Sand

Hardbottom habitats within the North Reddington Beach breakwater area occur in the northern and southern sectors of the survey block. Within the northern reach of the area surveyed there is an area of high relief dense hardbottom (Figure 23). Octocorals and sponges, with small-interspersed scleractinian corals, dominate this area of dense high relief hardbottom. This habitat changes into the larger scattered medium relief area totaling just over 1.0 acre in area. Another area of medium relief scattered and high relief hardbottom is located in the southeastern corner of the survey area. Sand areas between the hardbottom areas are dominated by echinoderms and mollusks, in particular the sand dollar (*Mellita quinquiesperforata*).

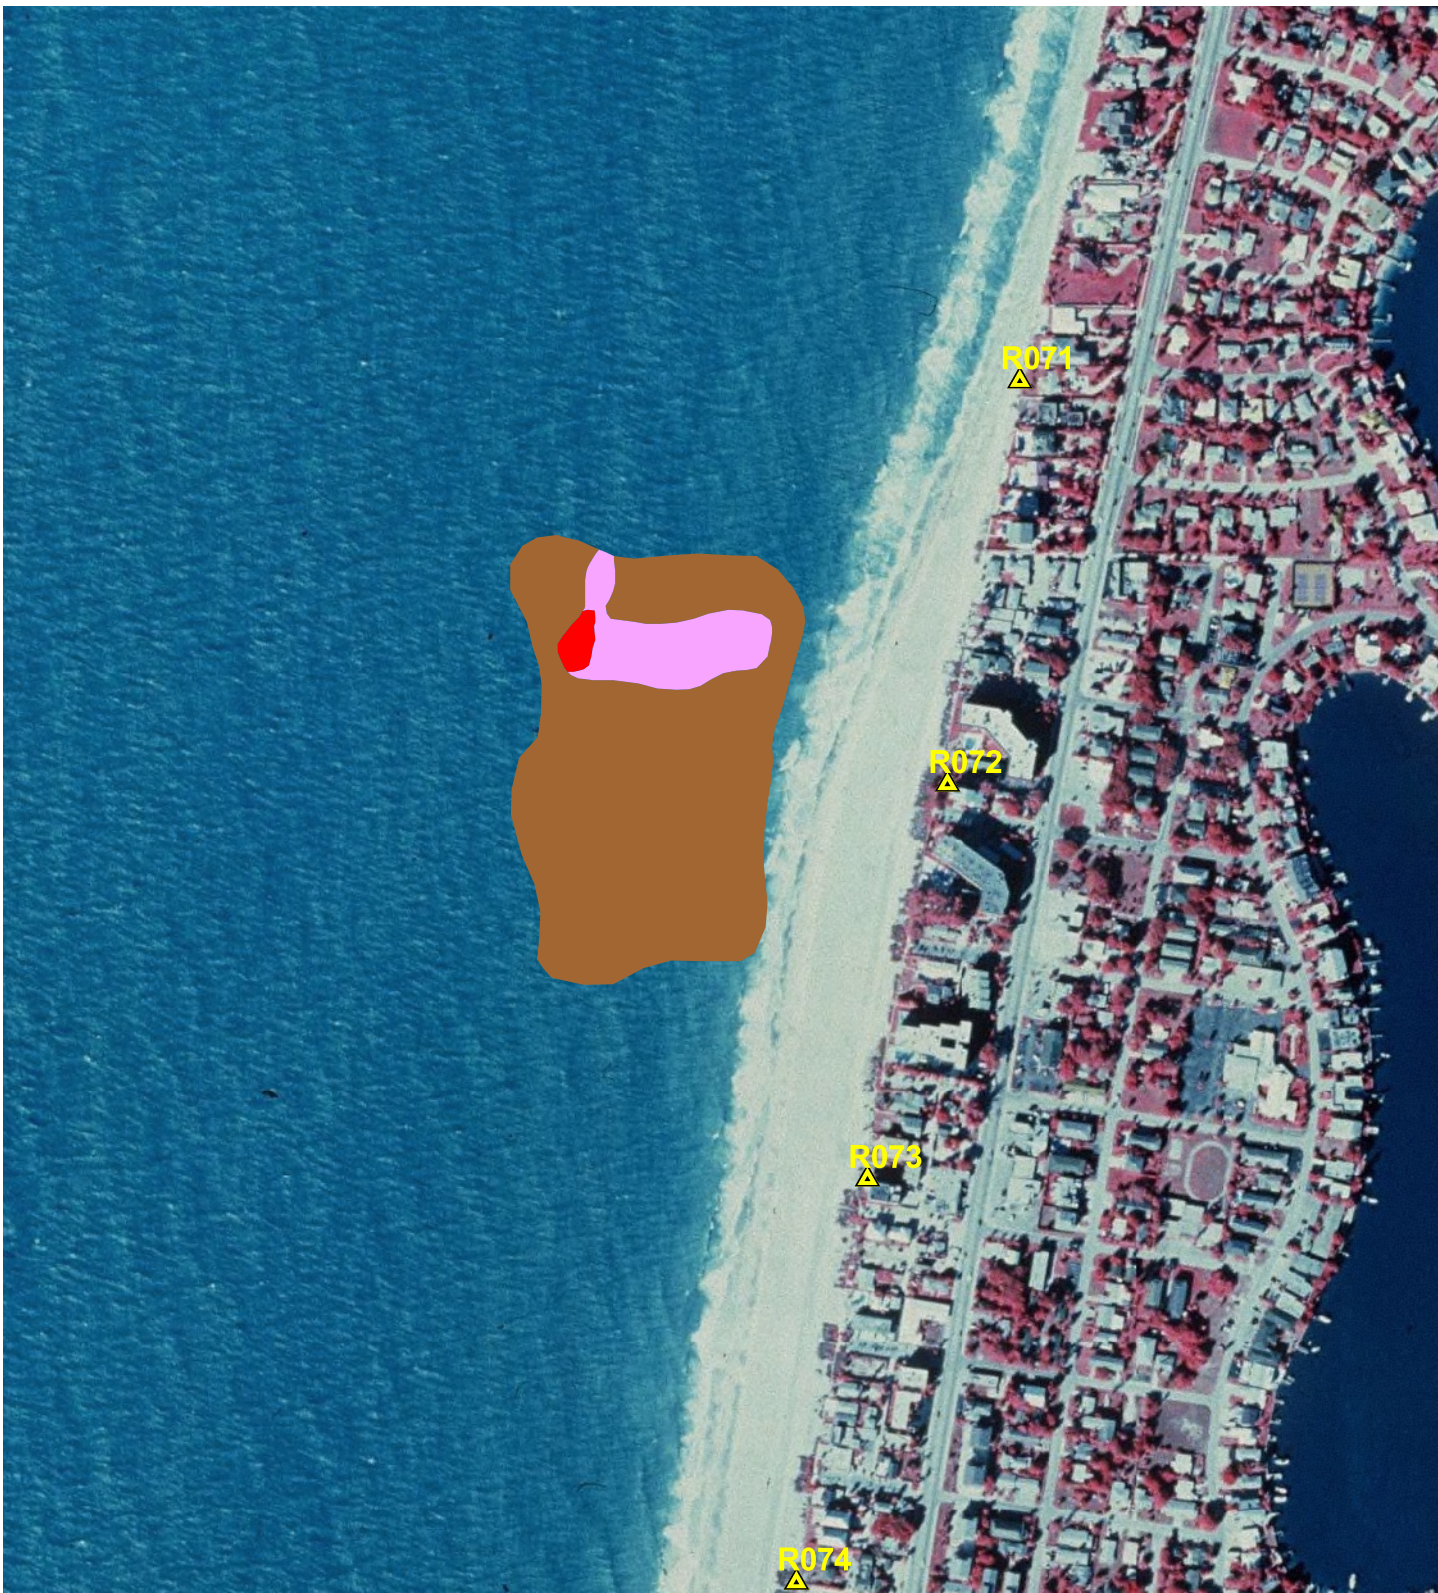
- ▲ FDNR Range Monument
 Pinellas Nearshore Bottom Classification Map
 ■ Dense Hardbottom (>75% Cover), High Relief (>100cm)
 ■ Scattered Hardbottom (20-75% Cover), Medium Relief (30-100cm)
 ■ Sand

Hardbottom habitat within the Indian Rocks Beach breakwater survey block included 2.3 acres of scattered medium relief habitat in the northern section of the survey area. A small area (0.3 acres) of high relief dense hardbottom habitat is also found in the northeast corner of the survey block. This area exhibits more exposed rock area and larger gorgonian and sponge species. The majority of the area surveyed within this area was open sand habitat (14.0 acres).
